**December 27, 2018 CenturyLink
Network Outage Report**

A Report of the Public Safety and Homeland Security Bureau
Federal Communications Commission
August 19, 2019

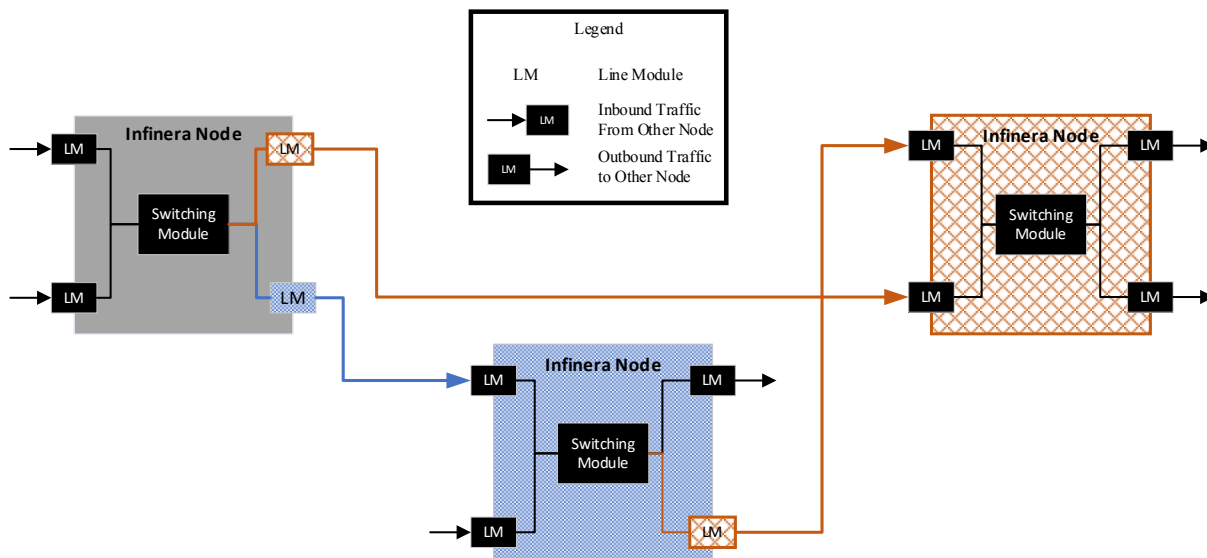
Figure 1: Conceptual Infinera Node Interconnection Diagram

inbound line module to the correct port on the correct outbound line module. This report refers to this successful traffic direction as “synchronization.” Correct synchronization ensures the line modules internal to the node are mapped correctly. Lack of synchronization would cause network data to drop or be corrupted as either an inbound line module would send traffic to the wrong outbound line module, or an outbound line module would attempt to receive traffic from the wrong inbound line module. Figure 1 conceptually shows how the Infinera nodes, line modules, and switching modules act together to send and receive network traffic from other nodes across the country.

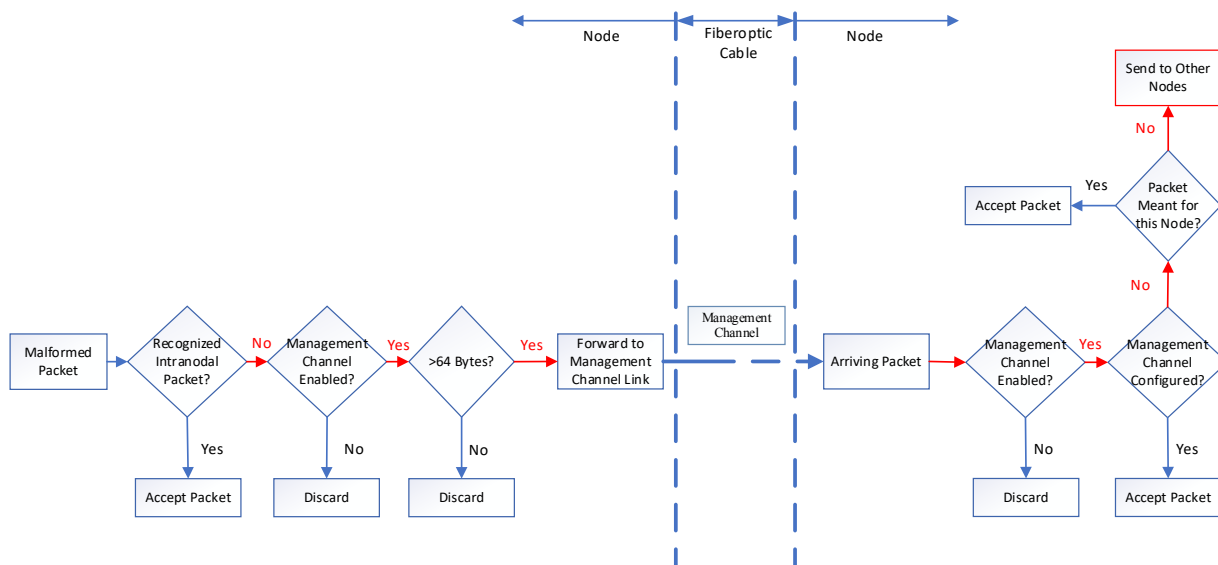
Figure 2: Malformed Packet Distribution Flow Chart

11. The switching module that generated the malformed packets sent them as network management instructions to a line module. Figure 2 illustrates how the malformed packets then flowed through the network.²² The packets were examined through a sequential series of conditions that produced either a “yes” or a “no” response. As shown in Figure 2, the malformed packets were able to pass each condition without being discarded. Because the packets were larger than 64 bytes, they were not stopped by the filter. Finally, while not shown, each malformed packet also passed the checksum condition, which is a test to determine if any errors occurred during the transmission of the packet, such as the changing of one or more bits in the message or if the message was randomly formed. As a result, the packets were transmitted along the enabled and unconfigured proprietary management channel.²³ The arriving malformed packets passed each condition at the nodes at which they arrived.

12. Due to the packets’ broadcast destination address, the malformed network management packets were delivered to all connected nodes. Consequently, each subsequent node receiving the packet retransmitted the packet to all its connected nodes, including the node where the malformed packets originated. Each connected node continued to retransmit the malformed packets across the proprietary management channel to each node with which it connected because the packets appeared valid and did not have an expiration time. This process repeated indefinitely.

13. The exponentially increasing transmittal of malformed packets resulted in a never-ending feedback loop that consumed processing power in the affected nodes, which in turn disrupted the ability of the nodes to maintain internal synchronization. Specifically, instructions to output line modules would

²² Figure 2 is intended to be illustrative of the conditions that are implicated in this outage. It is not intended to be representative of all of the conditions on this path, nor their actual order.

38. After CenturyLink resolved the incident, it replaced the faulty switching module and shipped it to Infinera to perform a forensic analysis. Infinera's investigation is ongoing, but thus far Infinera engineers have been unable to replicate the malformed packet creation. CenturyLink and Infinera have taken additional steps to prevent a repeat of this particular outage. CenturyLink and Infinera reconfigured the nodes in the affected network by disabling the proprietary management channel. Infinera has disabled the channel on new nodes for CenturyLink's network and has updated the node's product manual to recommend disabling the channel if it is to remain unused. The service provider and vendor also established a network monitoring plan for network management events to detect similar events more quickly.³⁹ Currently, CenturyLink is in the process of updating its nodes' ethernet policer to reduce the chance of the transmission of a malformed packet in the future. The improved ethernet policer quickly identifies and terminates invalid packets, preventing propagation into the network. This work is expected to be complete in fall 2019.

- For unidentified failure modes, implementing filters can alleviate the impact of the failure. In this case, filters were designed to only mitigate specific risks. Thus, catch-all filters should be designed to only allow for expected traffic. In this event, the filter prevented transmission of packets 64 bytes or fewer over the proprietary management channel, regardless of packet content. Because other characteristics of the packet were not considered, the malformed packets were able to propagate.
